# Designs That Preserve Dollars:

Case Studies in Historic Rehabilitation Tax  
Credits

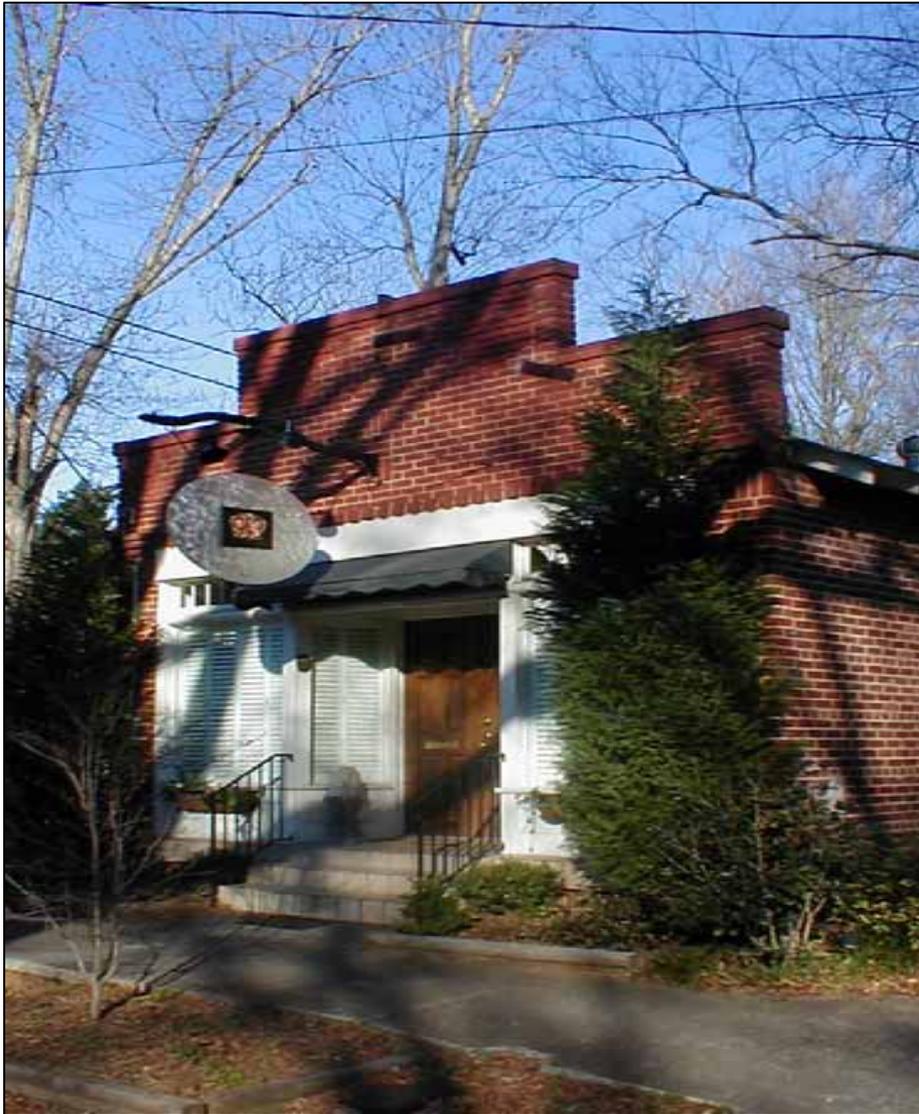
*This 1920's commercial building required only minimal changes to become a residence & studio.*

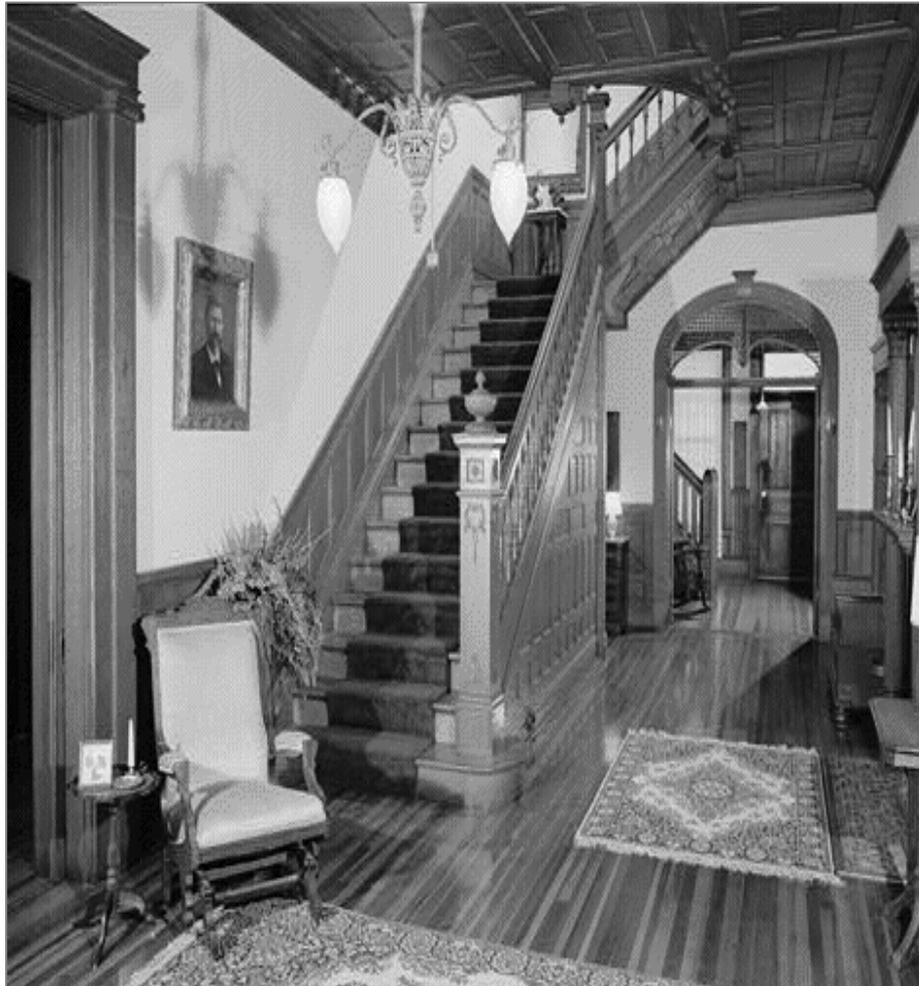
The stairs, floor, woodwork, walls, ceiling, and space of this Victorian entry hall have not been removed or obscured.

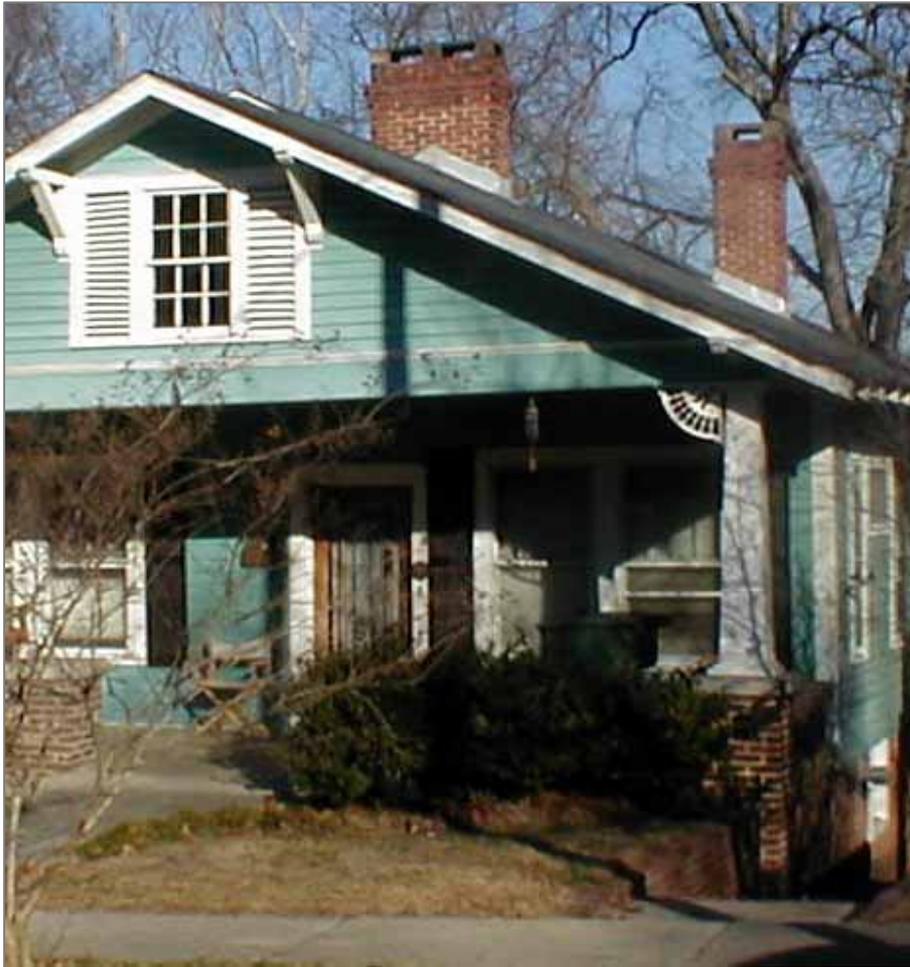
*A Victorian-style porch bracket has been added to this Craftsman Bungalow.*

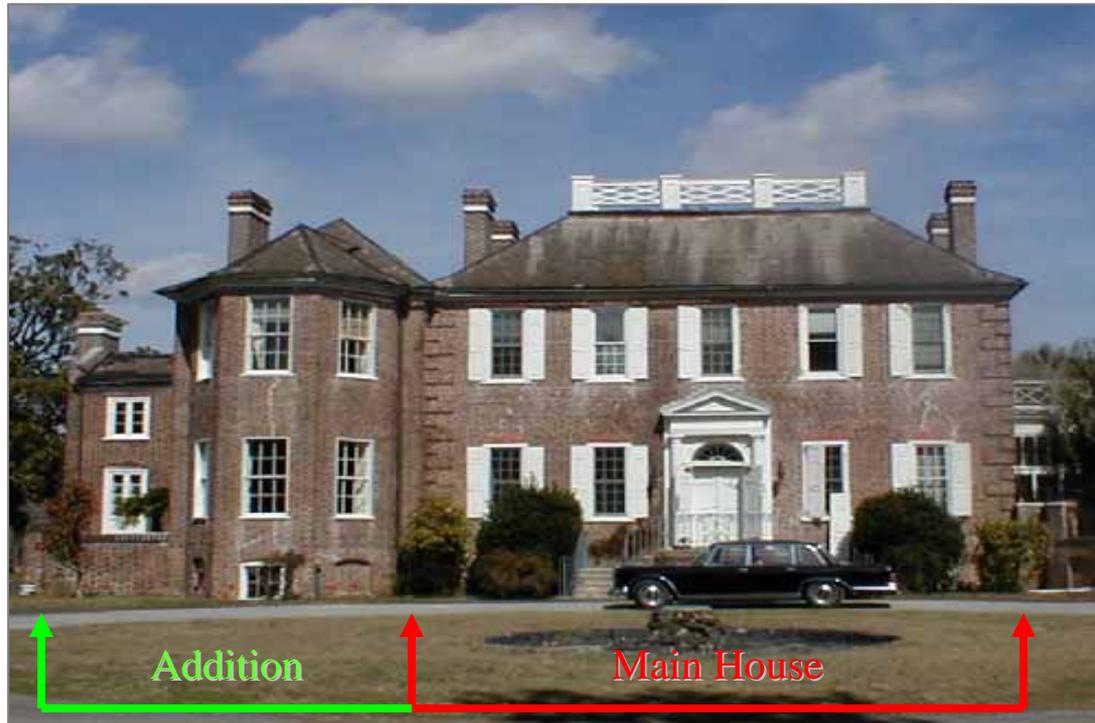
The 1730 main house and the 1787 addition of this property have both been retained and preserved

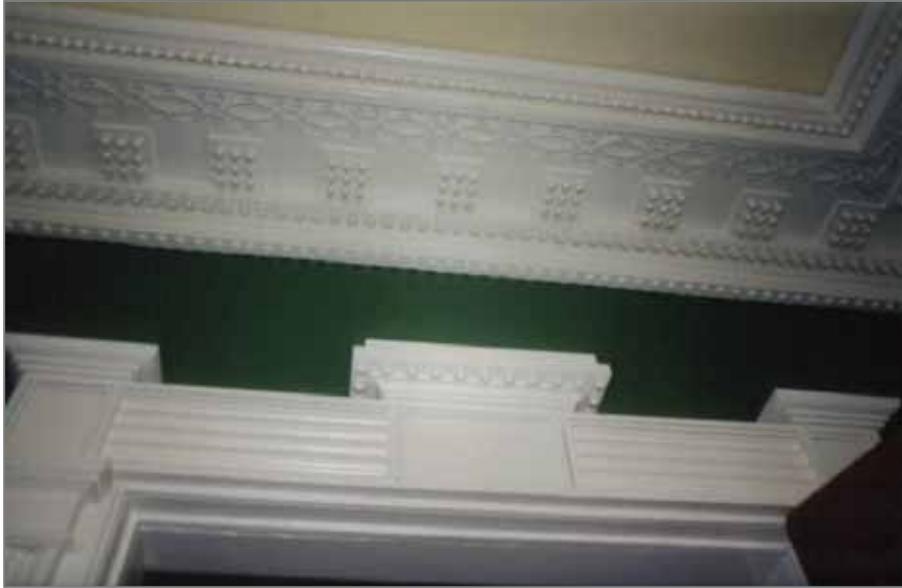
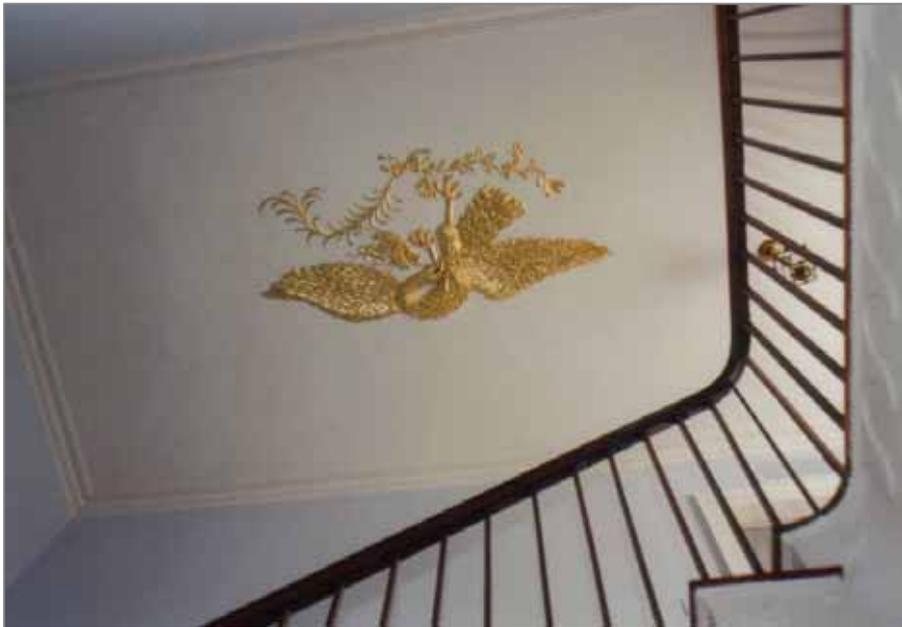
This decorative woodwork and plasterwork are unique to this historic property.

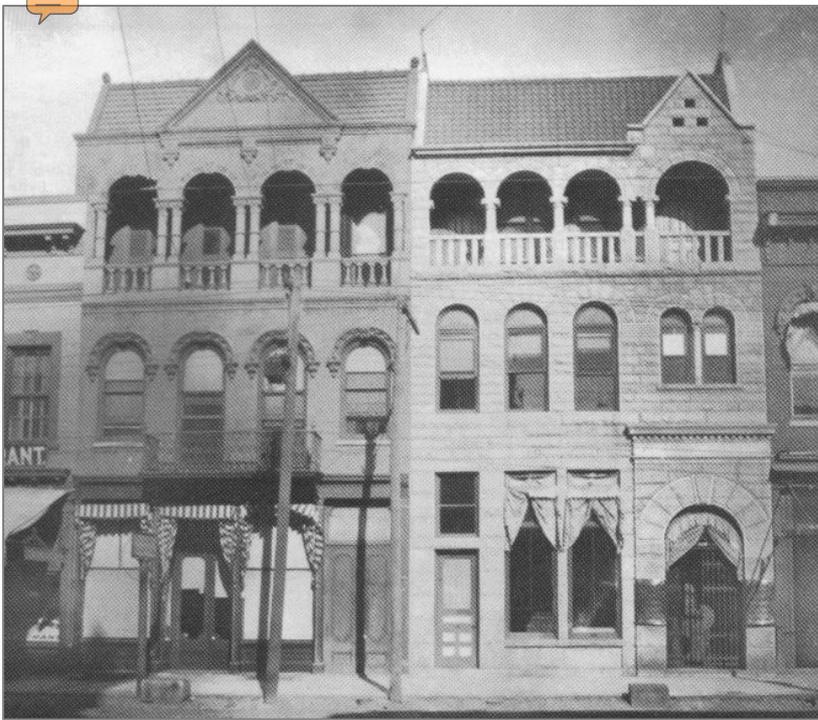
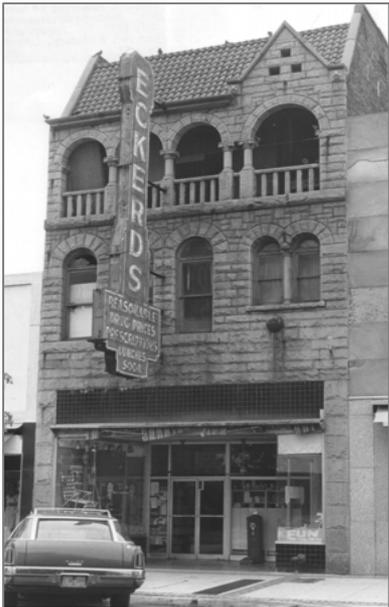
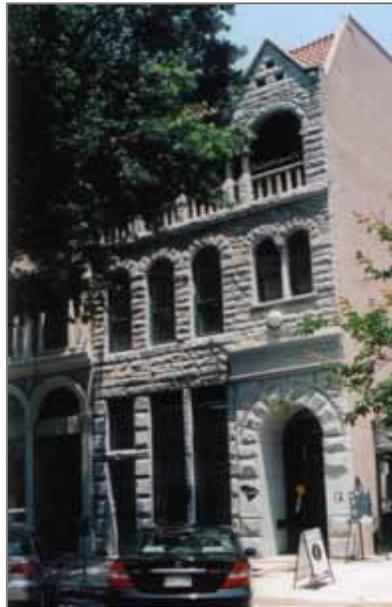
This building storefront was altered in the 1970s and restored based on the above photograph.

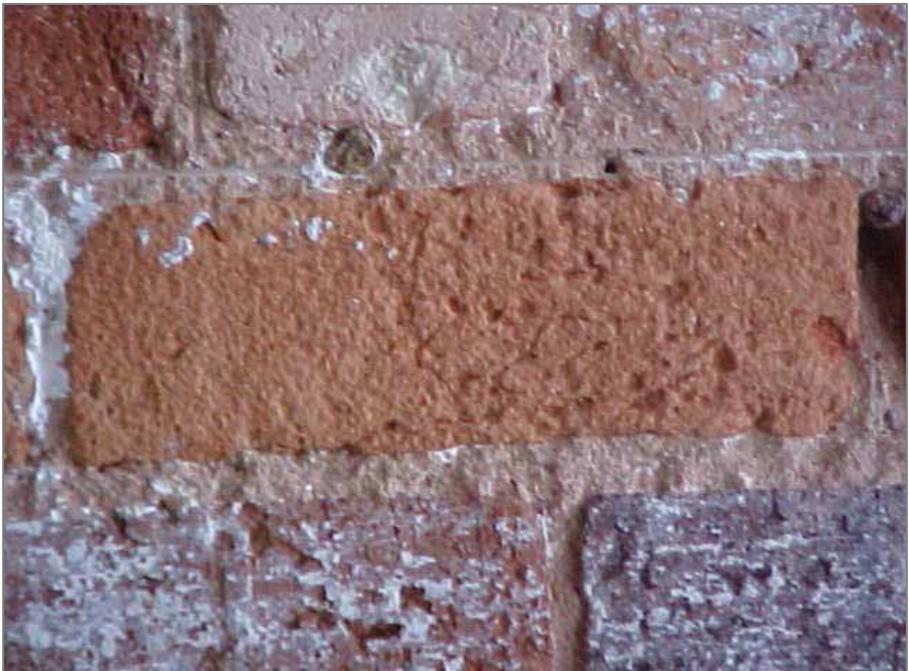
This interior was sandblasted to remove paint and is permanently damaged from the process.

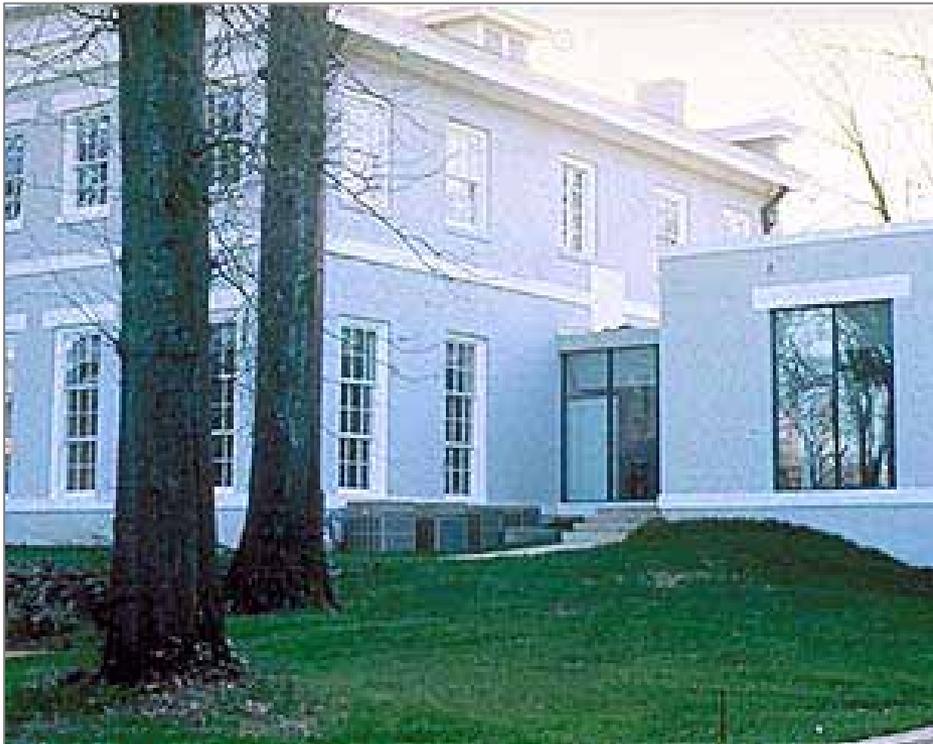
The addition on the right has compatible features but is clearly marked as new.

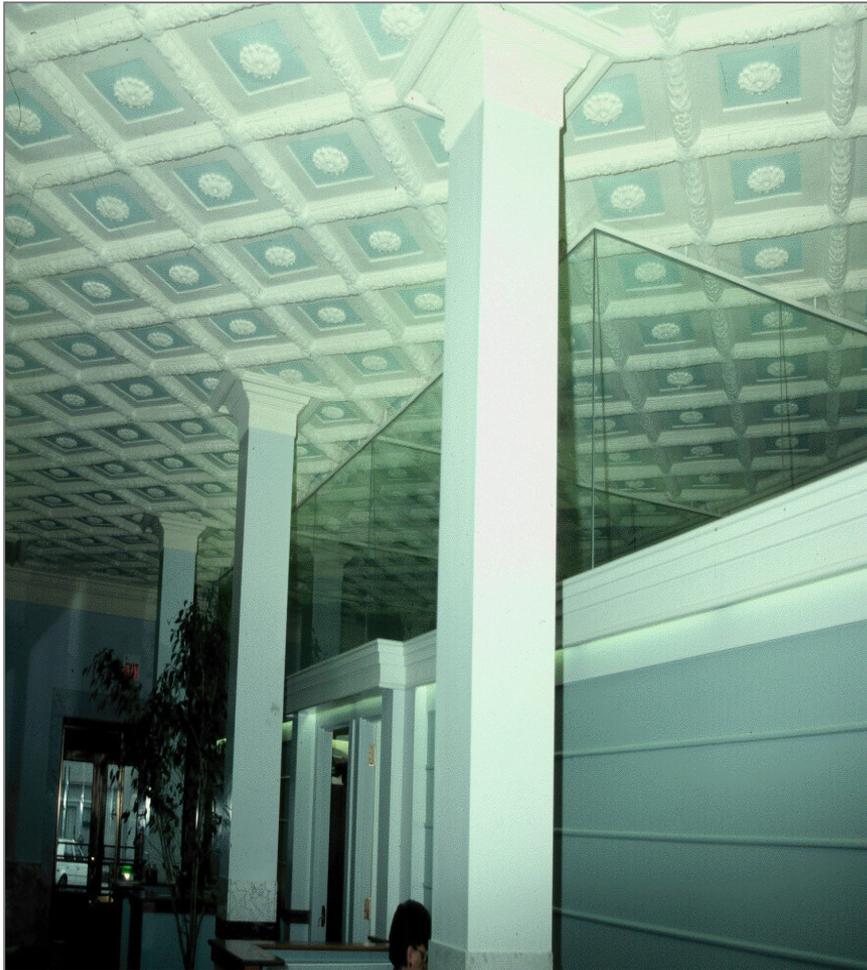
This partition has been added to create a new office but can be removed by later tenants.

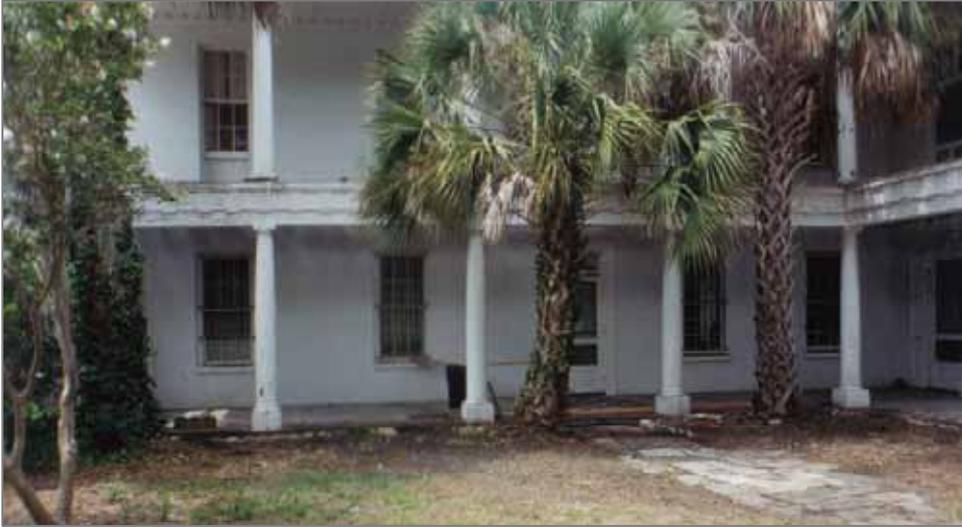
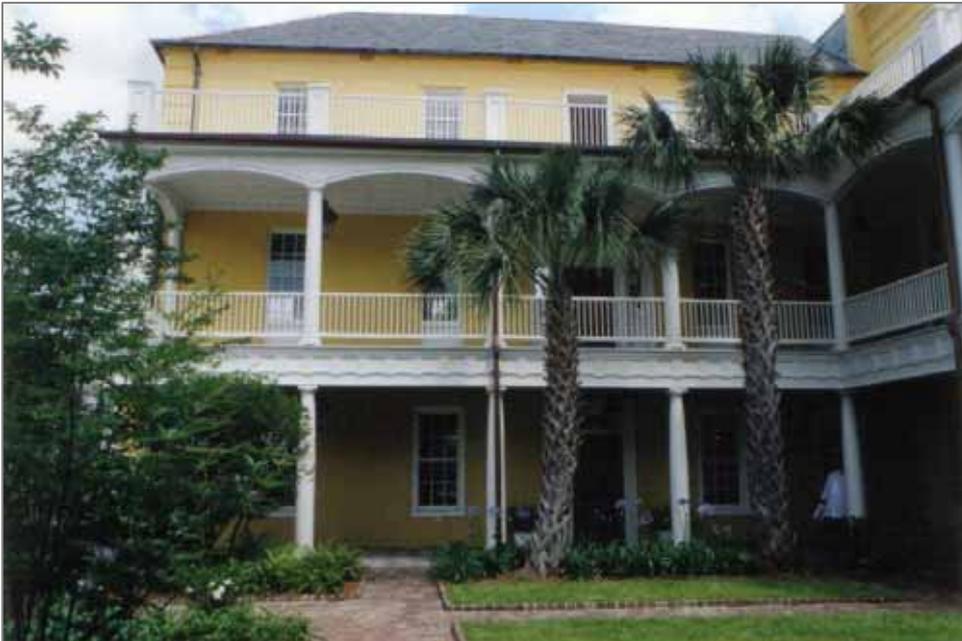
-Exterior Work listed

-Paint

-Railings

-Window and woodwork  
repair

-Landscaping

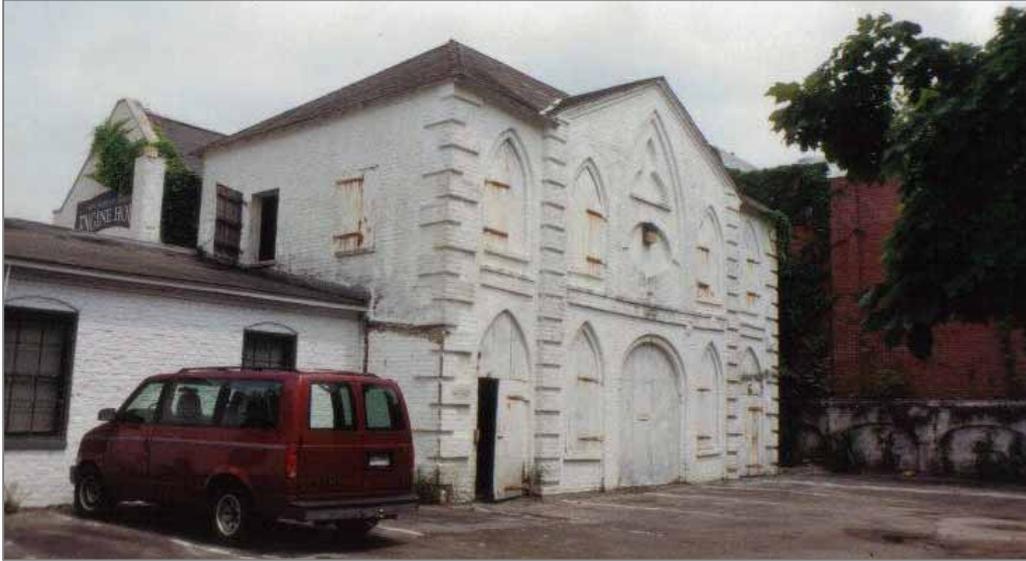
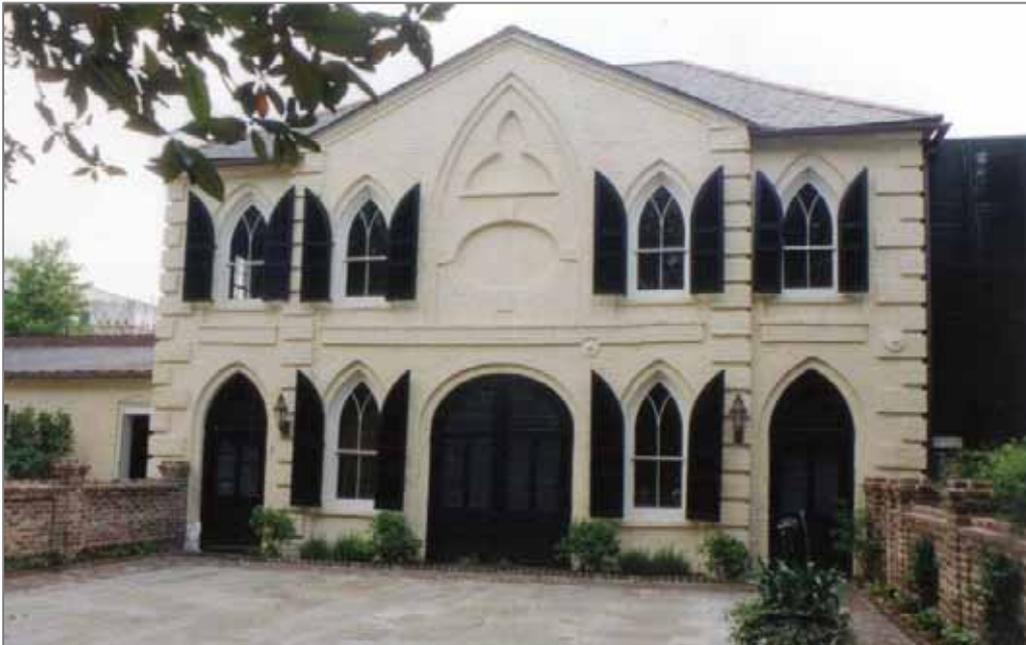
- Outbuilding rehabilitation
- New painting
- Restored slate roof
- Restored shutters
- Restored windows
- Restored Doors
- *New compatible landscape*

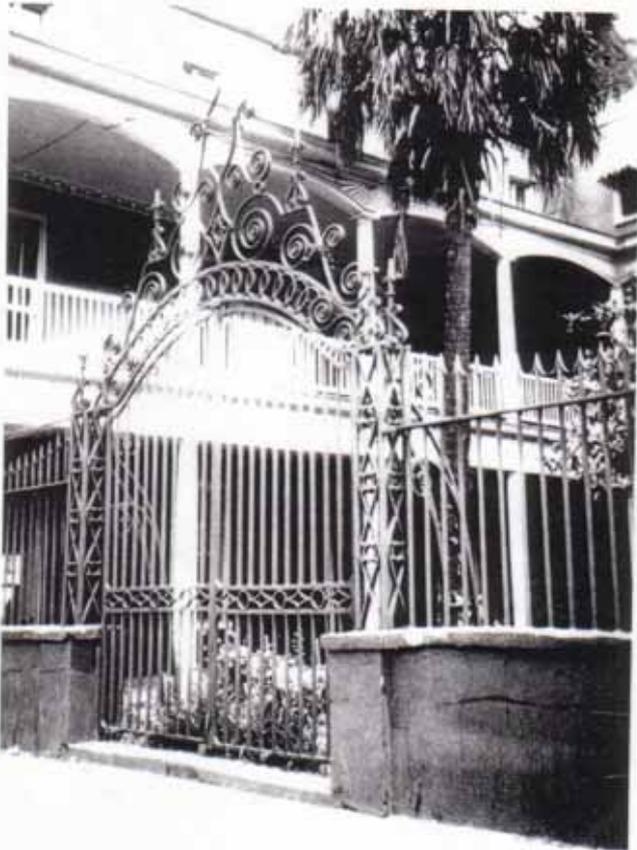
HP-4 Gate detail, ca. 1925.  
Gate was removed in 1929.  
Note upper piazza ceiling, replaced in  
1940s by asbestos panels.

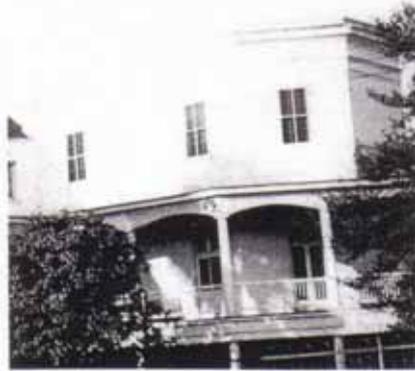
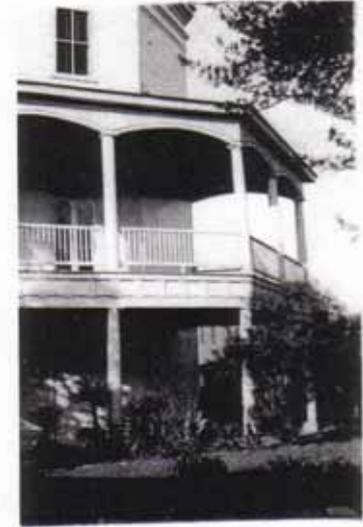
HP-5 King Street facade, ca. 1940.  
The 6/6 sash shown at Addition in 1925  
view have been replaced by 2/2 sash.  
Similar 2/2 sash shown in south-front bay  
of third floor Main House, but the facade  
appears to have casement windows.

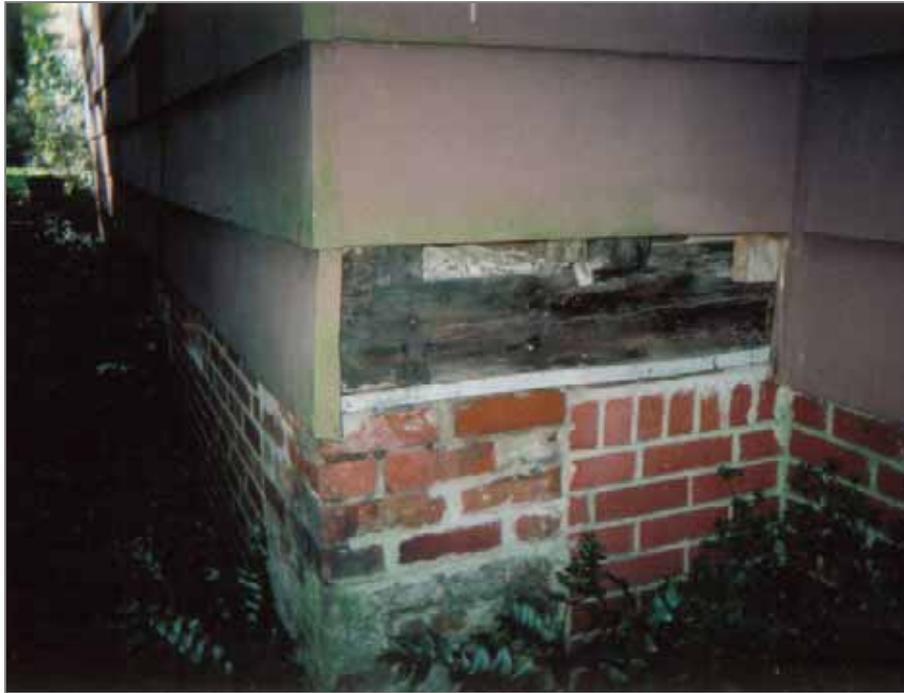
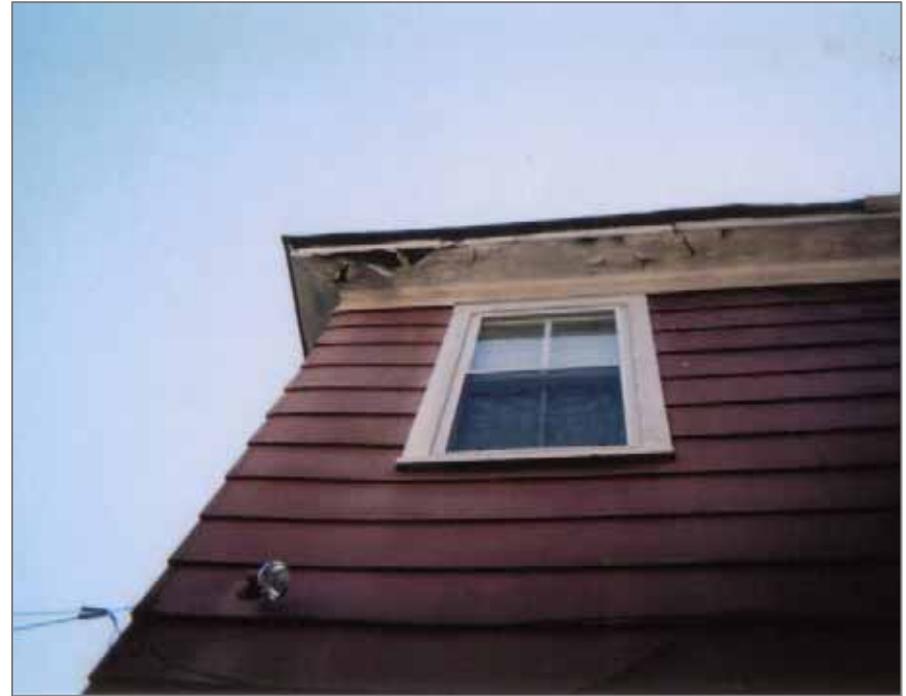
- Remove artificial siding and repair damage from insulation
- Repair front porch railing
- New insulation in attic and floors
- Reconstruct back porch

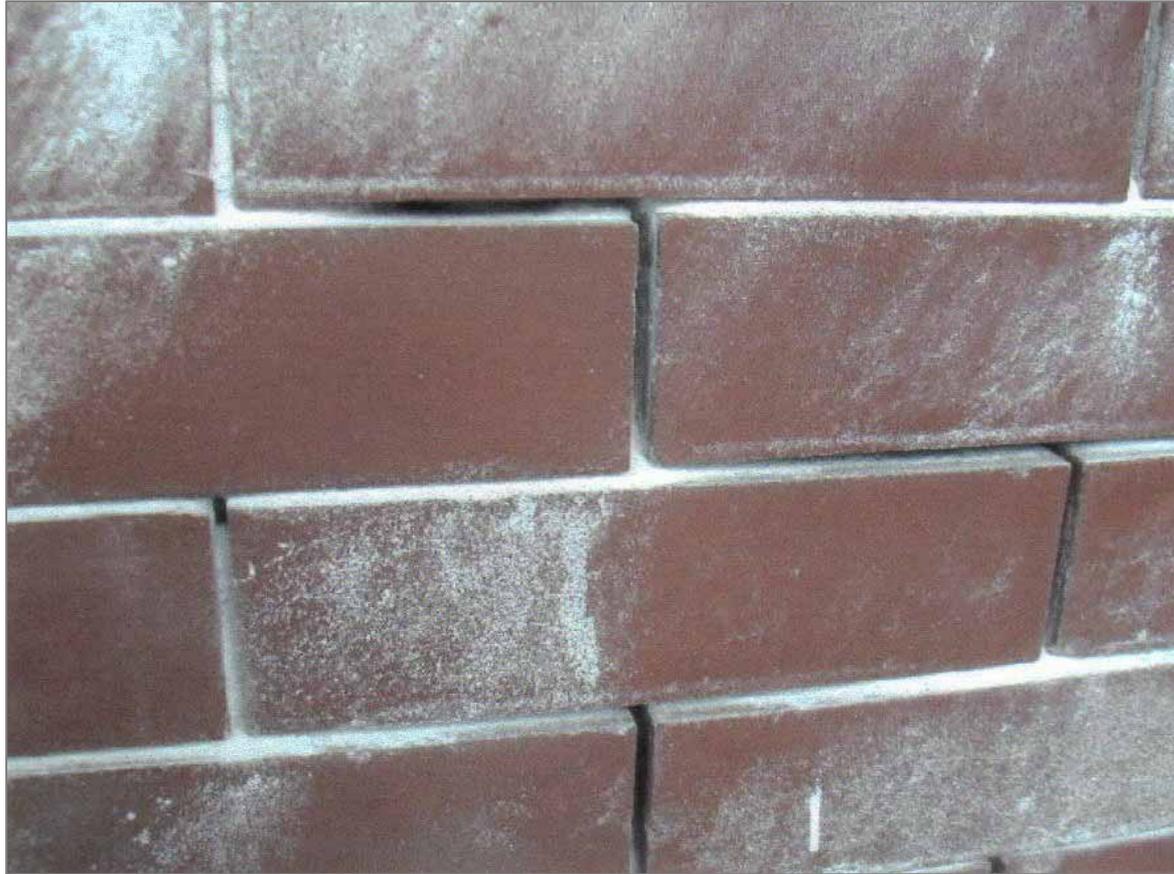
- Re-point all deteriorated mortar in brickwork
- Repair exterior stucco by patching
- Re-point brick piers and even out foundation

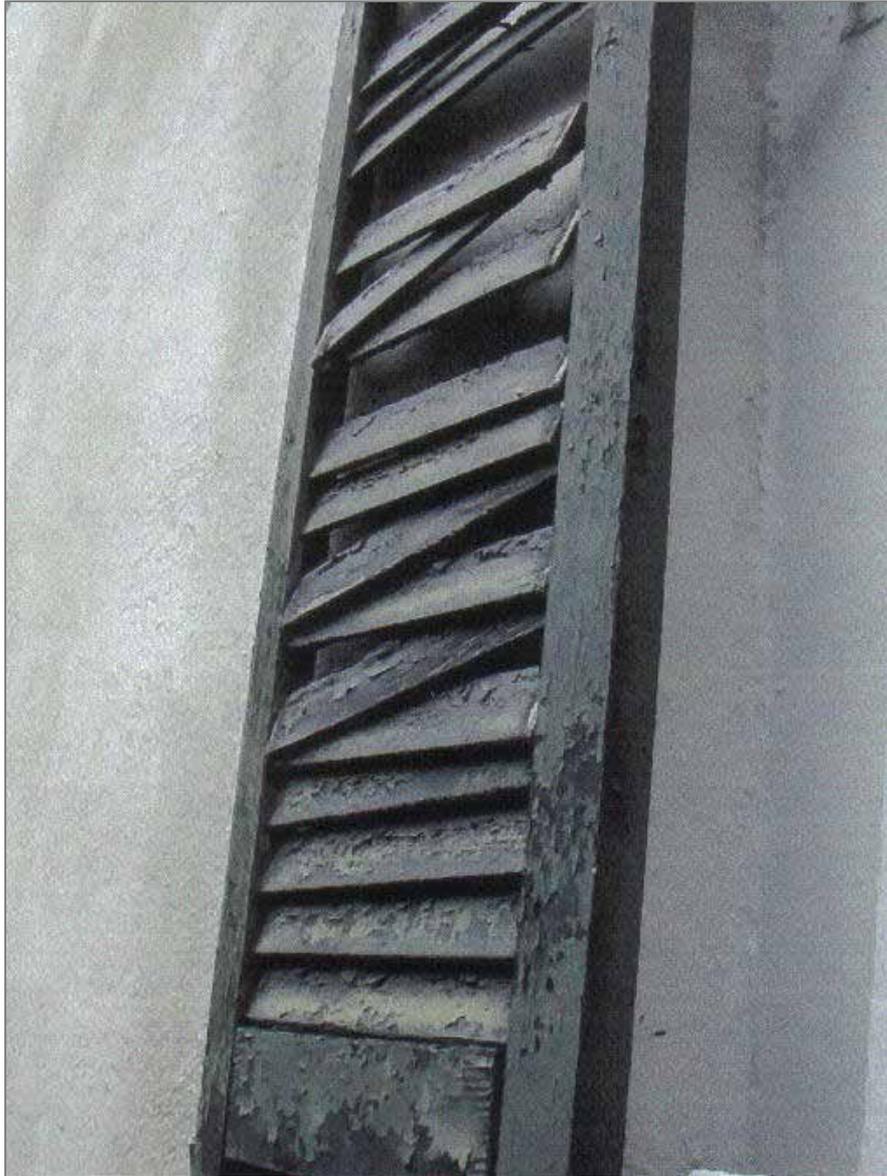
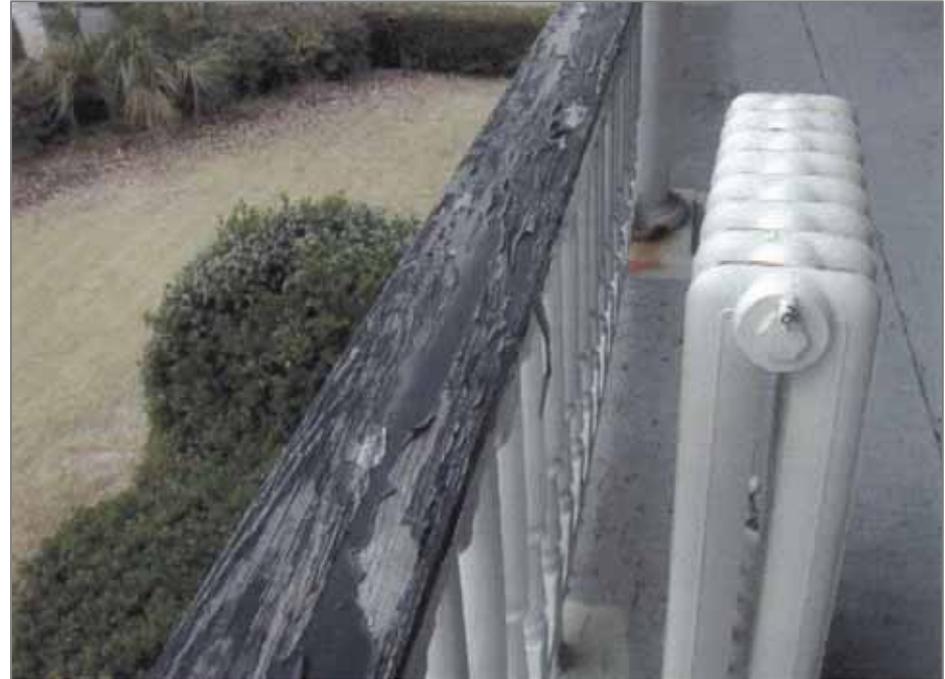
- Shutter repair and restoration
- Repair roof slates
- New gutters
- Scrape, repair, and paint wood doors, windows, and trim

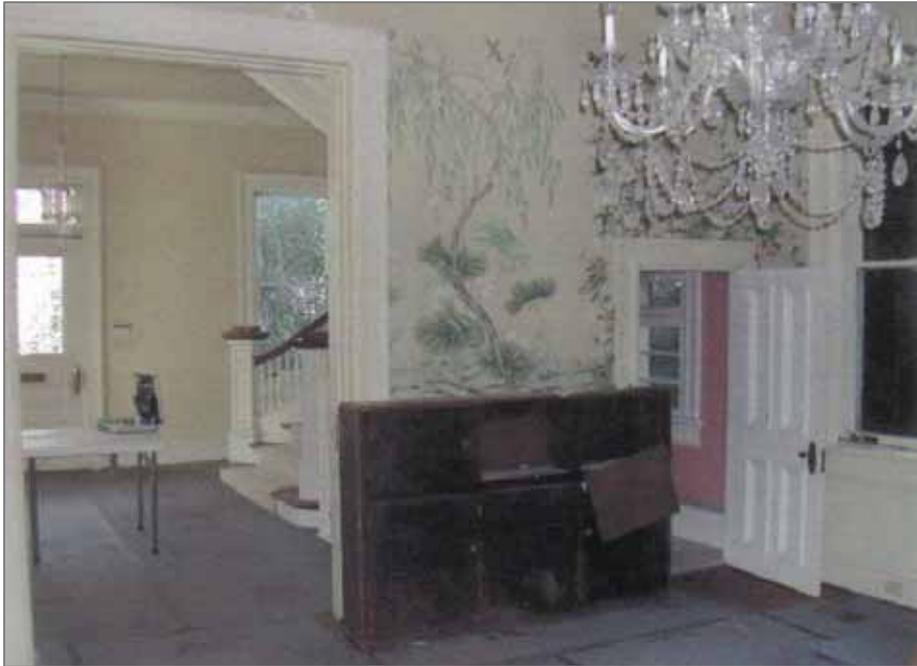
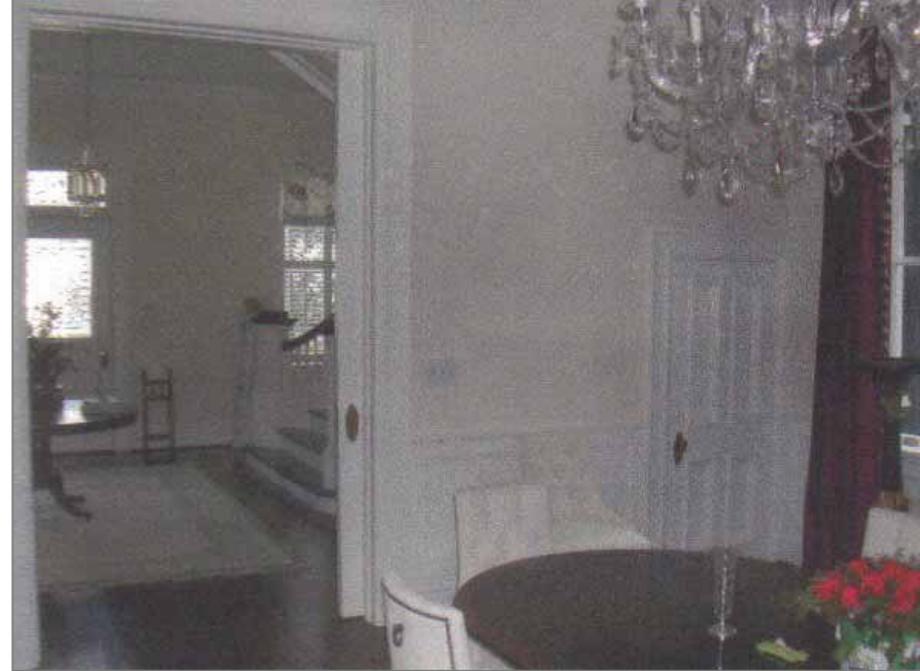
- Historic plaster repair
- Attic Insulation
- *Floor plan changes*

- New electrical system
- New plumbing system
- New HVAC system

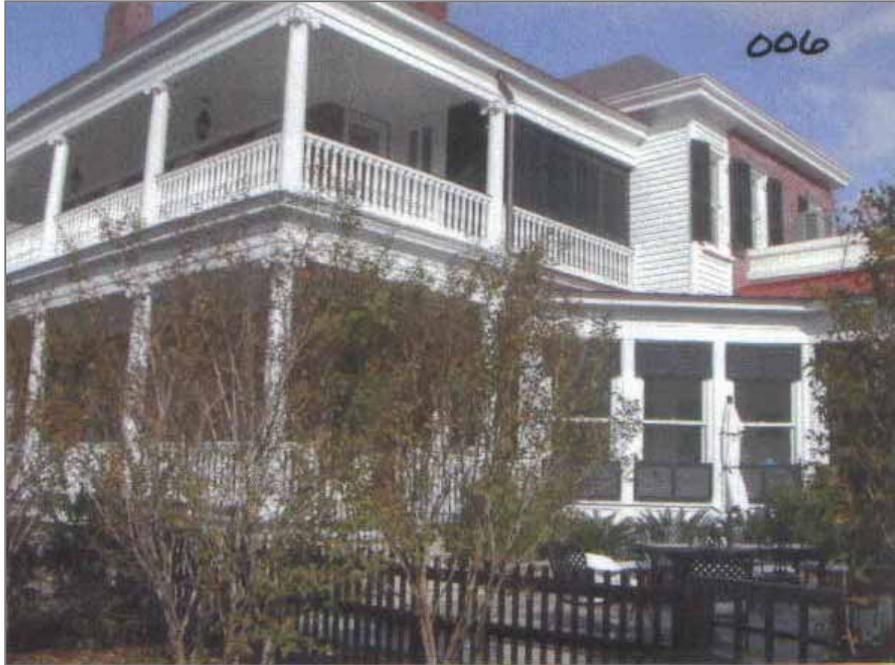
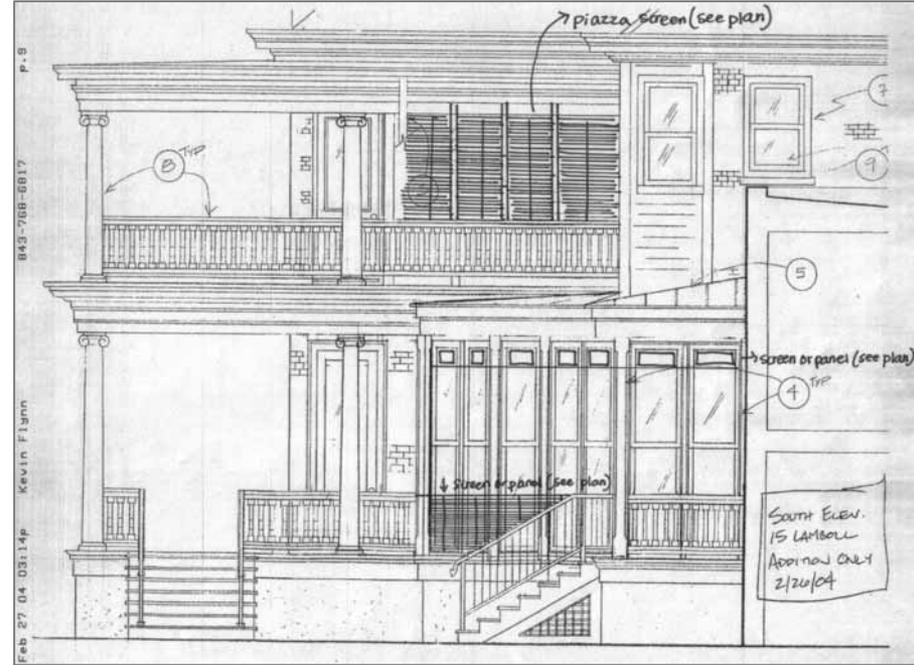
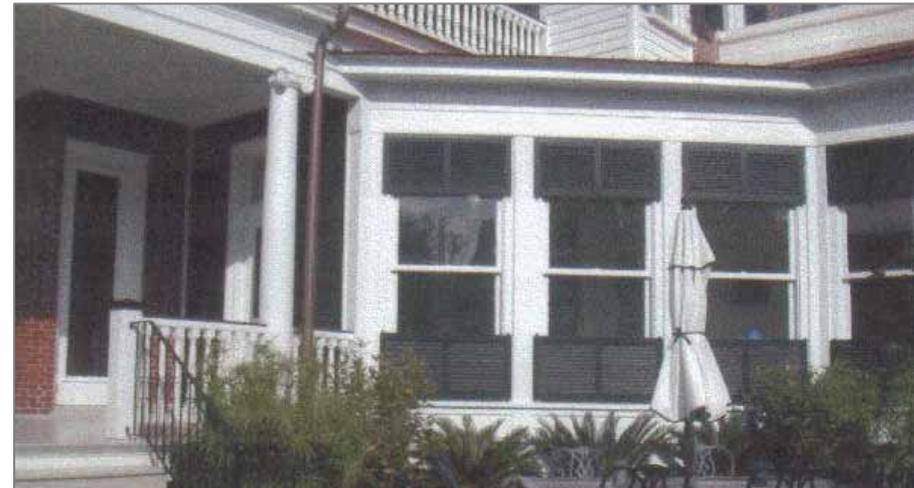
*-New one-story addition*

*-Landscape changes*

*-New garage*
